# Upgrading from POWER5 to POWER6 @ Australia Post

2009 IBM Power Systems Technical Symposium. 10-13th August, Sydney, Australia

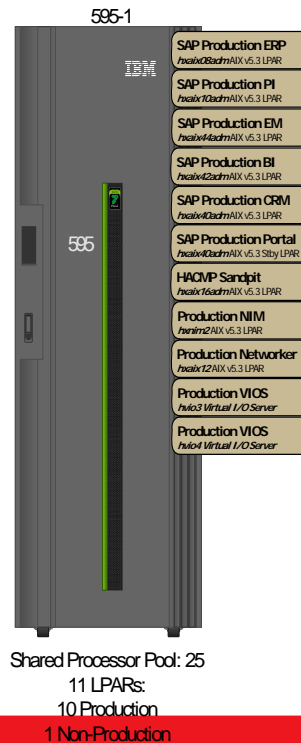
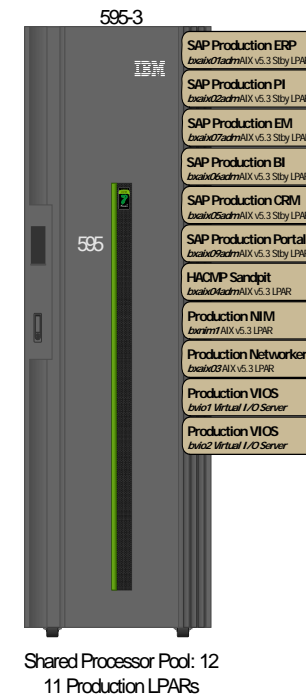
~80 LPARs

- ❑ An important note: **All of my LPARs were virtualized**; i.e. micro-partitioned, virtual I/O (VIO) for all disk and network devices.
- ❑ All physical devices were owned by the Virtual I/O servers (VIOS).
- ❑ There is **always an exception!** One LPAR had FC adapters for Tape.

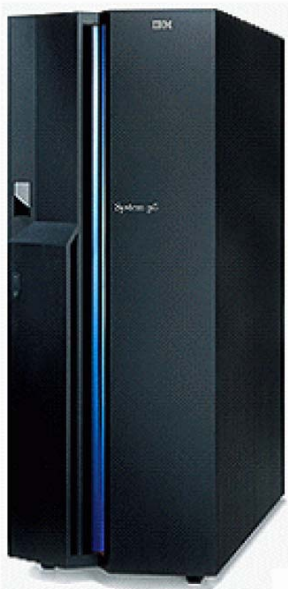
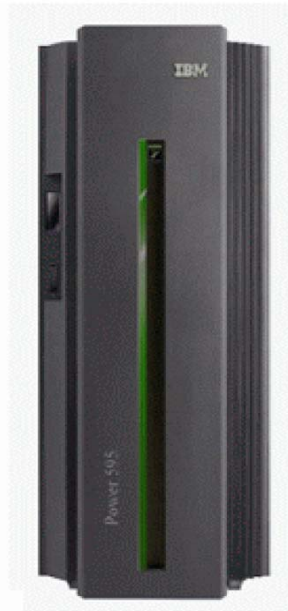
- ❑ I needed to upgrade my existing System p® 595 (9119-595) landscape to the new POWER6 595 (9119-FHA).
- ❑ **MES upgrade.** MES stands for Miscellaneous Equipment Specification. An MES upgrade includes any server hardware change, which can be an addition, improvement, removal, or any combination of these.
- ❑ An important feature of an MES upgrade is that the **systems serial number does not change.**

- ❑ Essentially, our upgrade from POWER5 to POWER6 involved moving the [existing I/O drawers](#) (including internal disks, FC, and Ethernet adapters) from the POWER5 frame to the POWER6 frame.
- ❑ Once completed, the POWER6 system would be powered up and the IBM CE (Customer Engineer) would then hand back the system to me.
- ❑ Attempt to bring up the LPARs on the new POWER6 server.
- ❑ This was the first time I had migrated to a newer POWER platform using the MES upgrade method, and I had [concerns](#).
- ❑ In the past I had migrated AIX systems to newer platforms with both the [old and new systems sitting side by side](#).
- ❑ For example, POWER4 to POWER5:
  - New 9119-595 sat next to the old p4 p690.
  - Connected 595 to SAN and network.
  - Started moving LPARs from the p690 (one at a time) by [restoring a mksysb](#) using Network Installation Manager ([NIM](#)).
